How to remove and replace the drum gasket on the Frigidaire/Kenmore Front Load Washer with notes on tub bearing replacement and inner tub replacement.

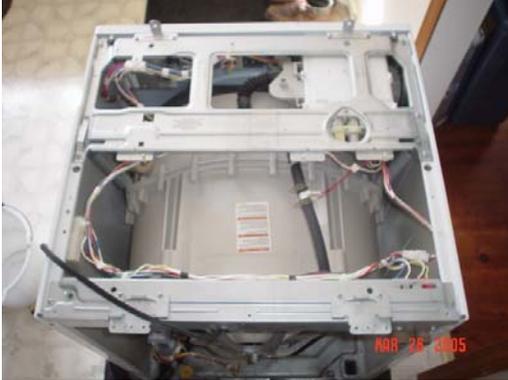
1. Pull top off. I have front controls, so the screws on the back allow the whole top to come off easily. Pull kick panel. Remove back panel.

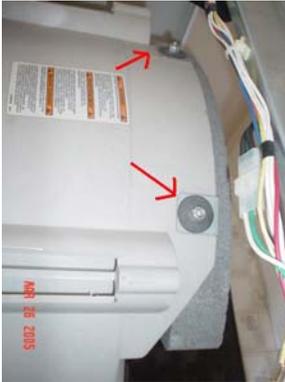
2. Loosen two screws that hold weight on back half and slide out weight. Leave screw on drum

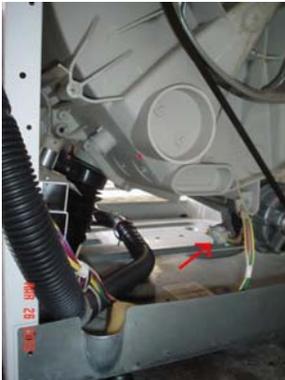
3. Remove drive belt. Cut zip tie, unplug motor and leave wiring in the bottom of the washer. Remove 4 screws that hold on motor and remove motor.

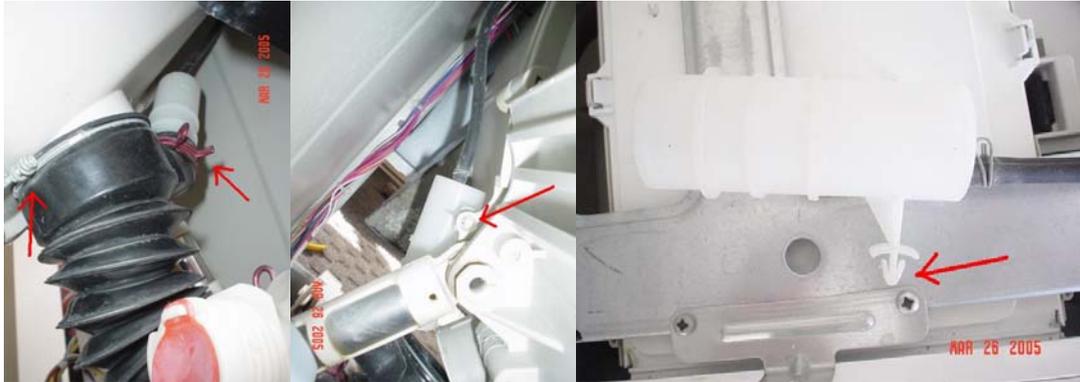
4. On front right, loosen screw and remove rubber drain from tub. Squeeze large snap ring and remove water level sensor (Thing that looks like an old fuel filter) from rubber drain also. Remove little hose from top of water

level sensor also. (NOTE: You can also disconnect the level sensor hose at the top of the washer. This will make it easier to re-connect, however you'll need to be careful that you do not damage the hose when you remove the tub assembly). Sensor will be removed WITH the drum.

I pushed the level sensor out from the back where it clips into the drum, this way I did not have to disconnect the small hose

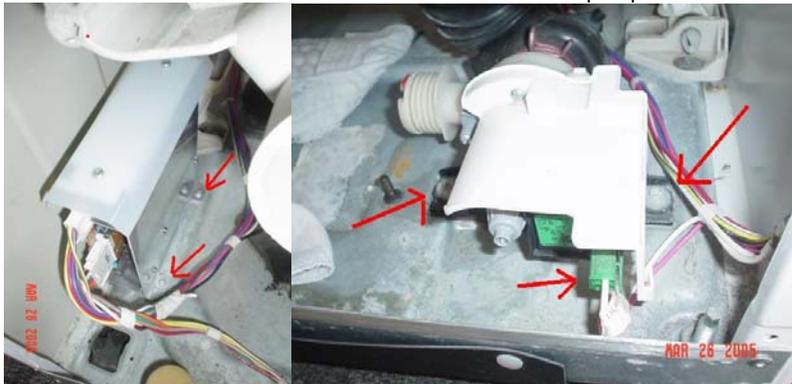
4a. At this point, you might want to remove the control board and pump motor. Each is secured by 2 screws and are easily removed. This will prevent accidental damage and give you more room inside the washer to work with. There are 2 connectors on the control board and 1 on the pump motor – be sure to remove those first.

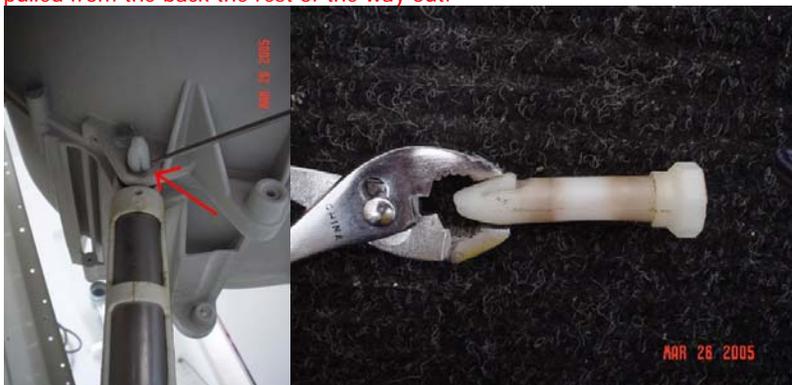
5. On shocks, push one lock area to allow the pint to be slid out of the tub and the shock will be free from the drum. Push pins through to the rear and remove. Will now be hanging from the springs.

These shock pins were stubborn, I squeezed the lock pin down and pushed with pliers in from the front, then pulled from the back the rest of the way out.

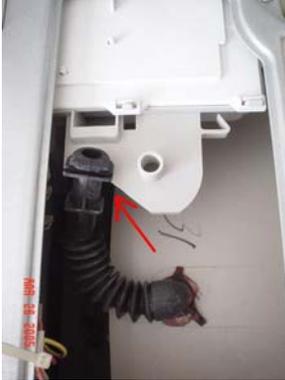
6. From top, slide out what looks like overflow tube from holder. Leave tube attached to the drum. Place support under drum. I used 2 5 qt. Ice cream pails, but they may be a bit light for the job.

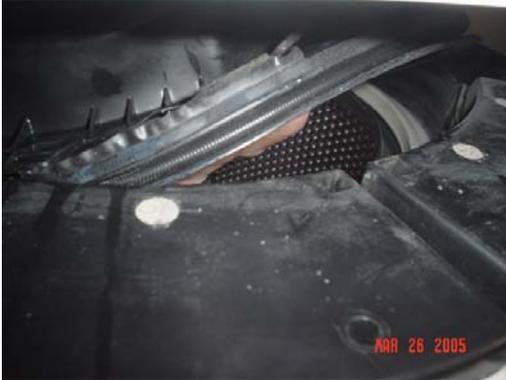
7. From front, go through glass opening. Drum will be hanging a bit funny, with the bottom swinging away from the front. From opening, start at bottom and pull rubber boot off of drum. Work around to the top. boot spring came off during this process. Best to do this, even though boot will be removed from washer later, because the spring clip on the water fill area needs to be removed from the boot and that is easier to do after the drum is removed.

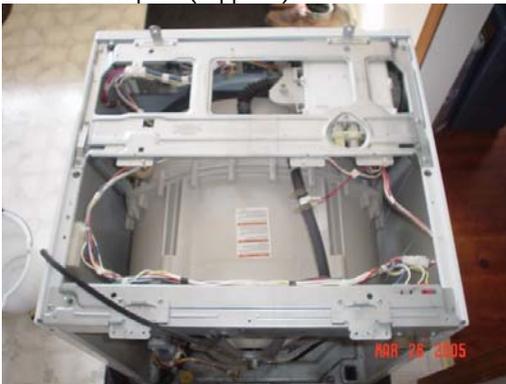
8. Drum should just be hanging from 2 large springs. Loosen and turn clip that goes over the top of the springs so they can be lifted and removed from the washer. Start on either side, lift spring, move toward center and lower to disconnect drum from the frame. Completely remove spring. Repeat on the other side. Drum should now be sitting on ice cream pails (supports).

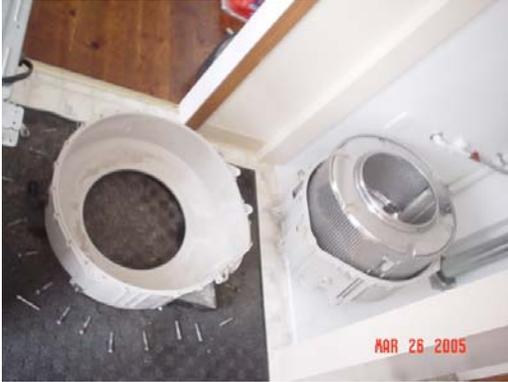
10. Lay drum on front face and start to remove screws that hold halves together. Once all screws are out, the back half with pulley (top half if sitting on face) easily lifts up from the other half.

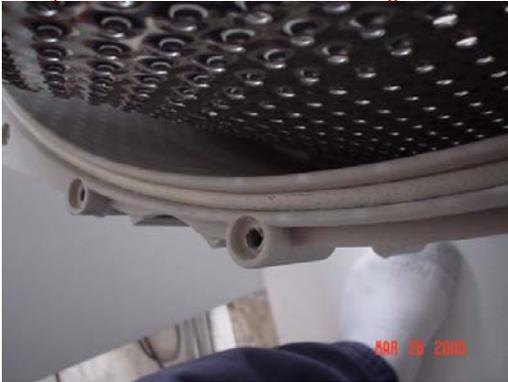
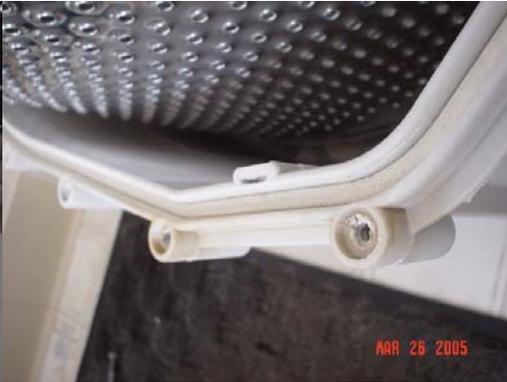
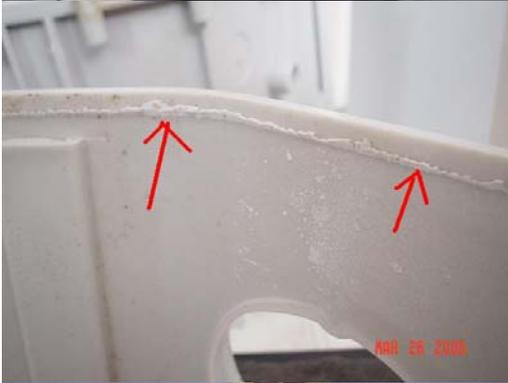
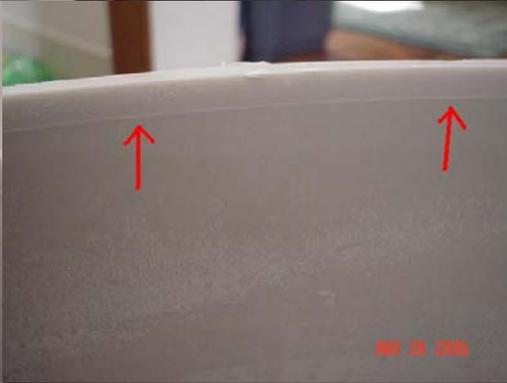
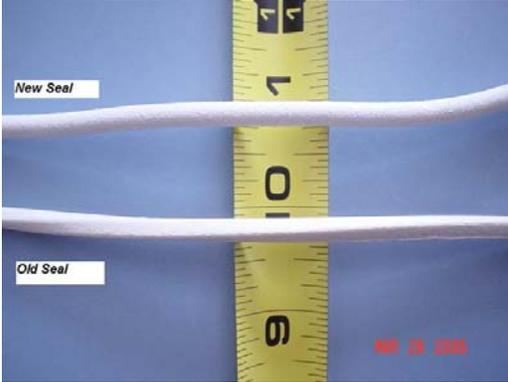
11. Remove and replace tub seal. New seal is thicker than old one....

My drum had some excess plastic flashing on the bottom compared to the top, I am not sure if this caused the 2 halves not to seat well together. I removed the flashing with an exacto knife. My washer was leak free for the first 1 1/2 years so I do not think the flashing was the root cause of the leak.

Tough for me to measure a big difference in seal thickness considering old seal has been compressed for 1 1/2 years.

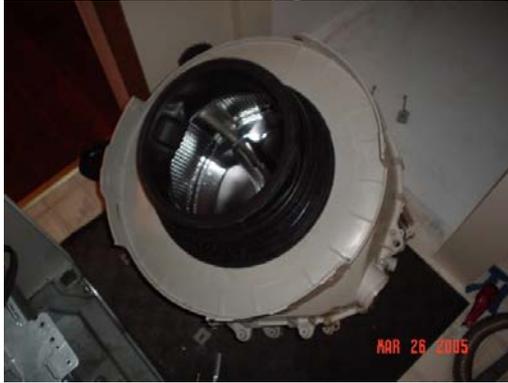
13. I had to remove the front weights also to get a clear shot at the lip to get the front boot back on. Remove screws and round metal clip/guide.

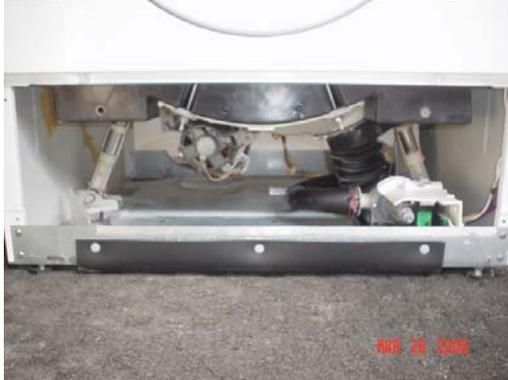
17. Had a %\$#%& of a time getting water fill tube spring clip back on. Helped to install drum support springs (big ones on top) and temporarily hang drum one hole to the rear to allow a little clearance in the front. Then use 2 vice-grips, replace spring clip by going through the front glass opening. Worst part of re-assembly...

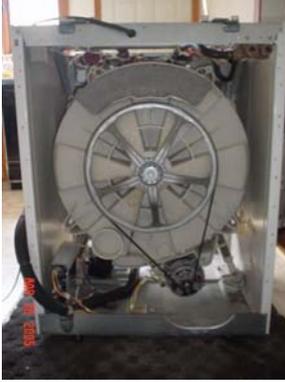
21. Finally, pull boot over the front of washer. Don't do this until drum is in fully, or the boot might not end up on straight and might pucker a bit.

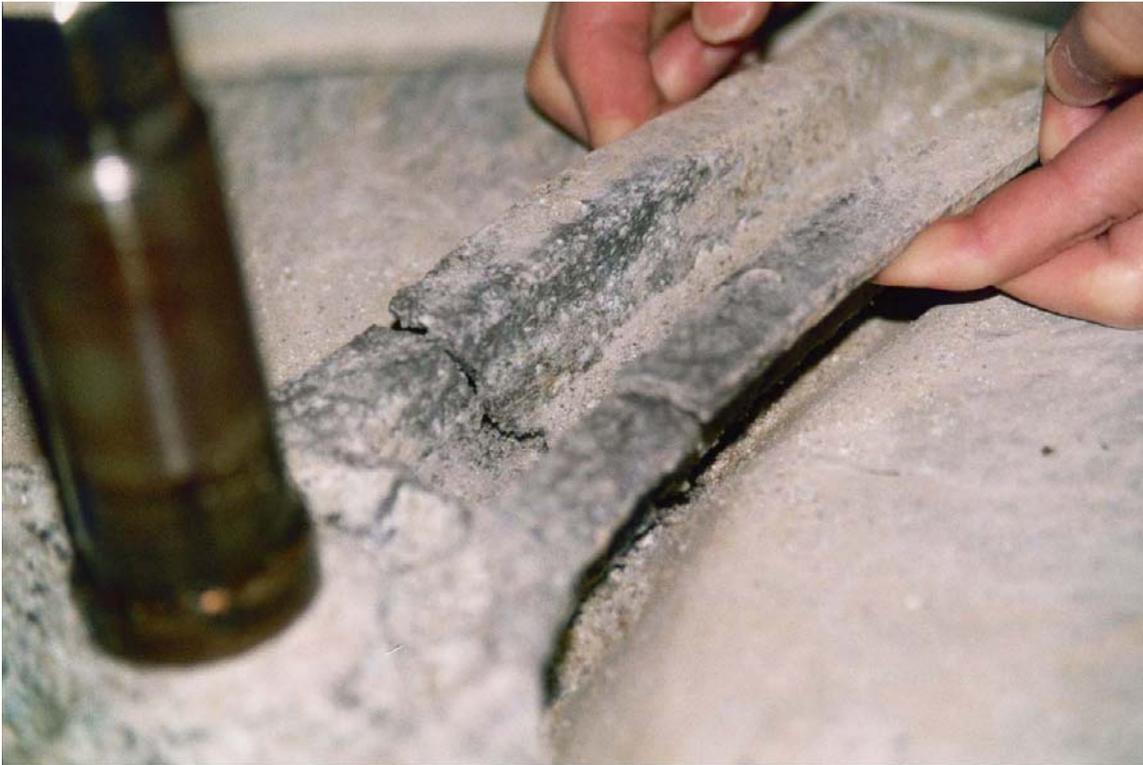
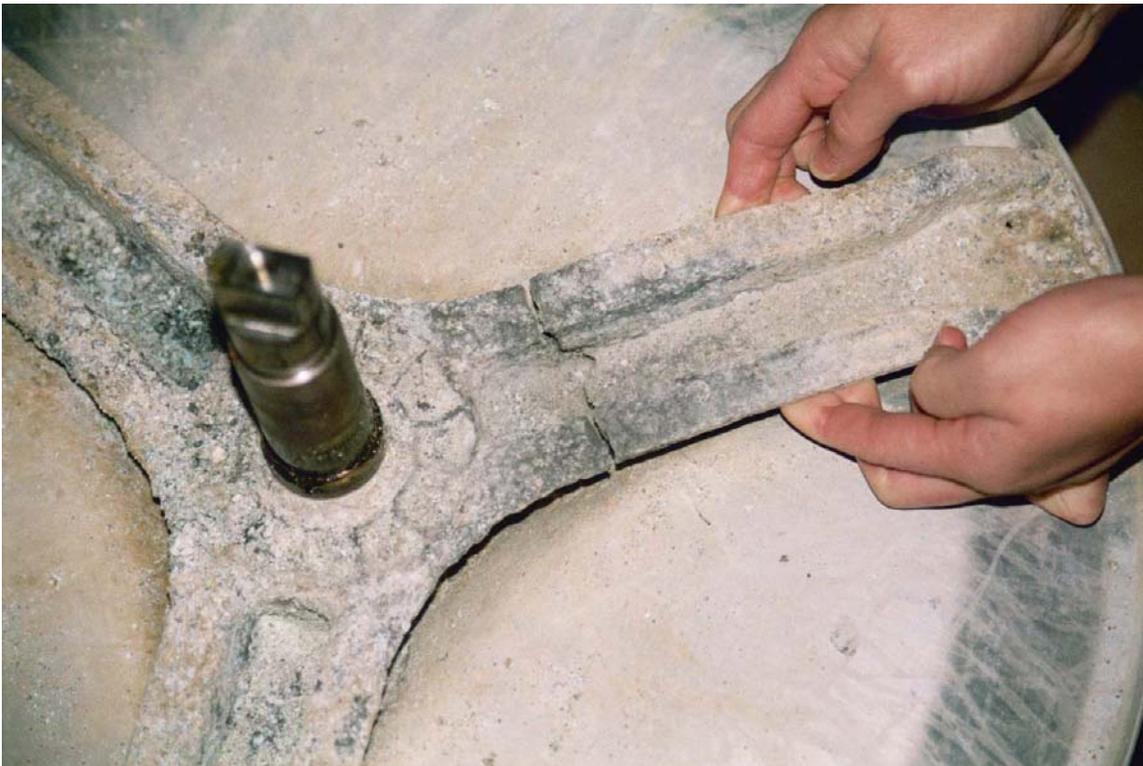
Cracked Support

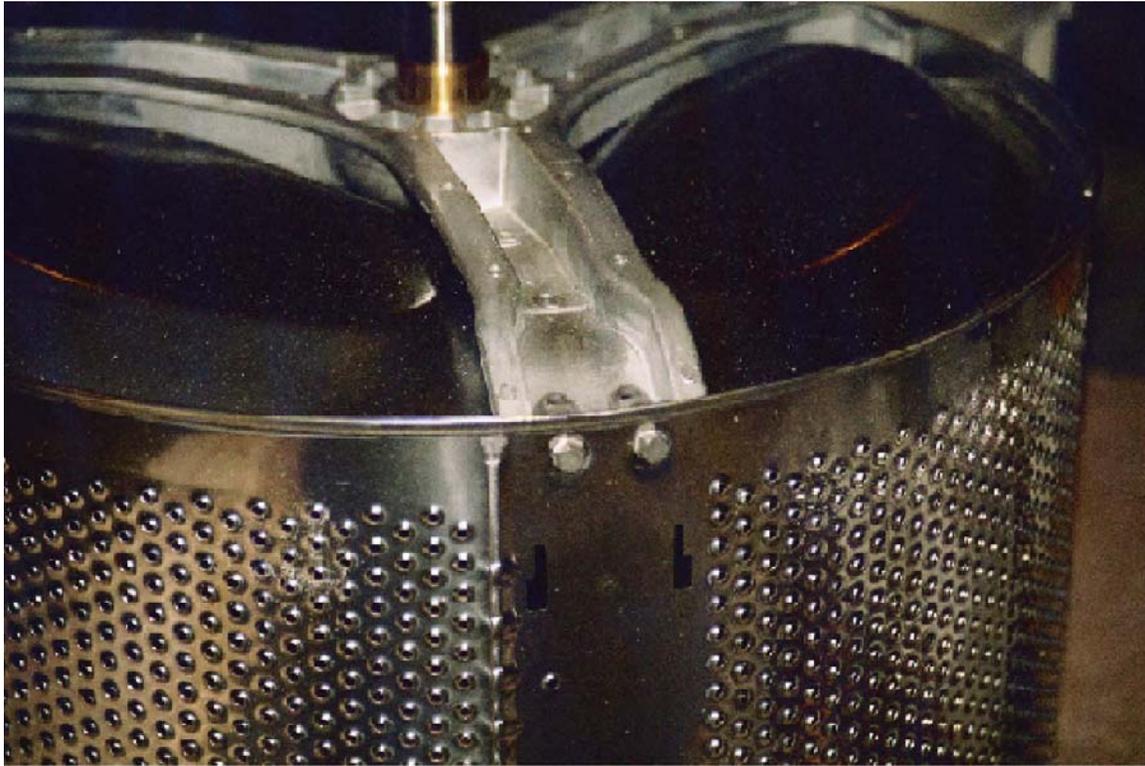
New tub – notice how support is attached (no welds)
