## ***How to remove and replace the drum gasket on the Frigidaire/Kenmore Front Load Washer with notes on tub bearing replacement and inner drum replacement.***

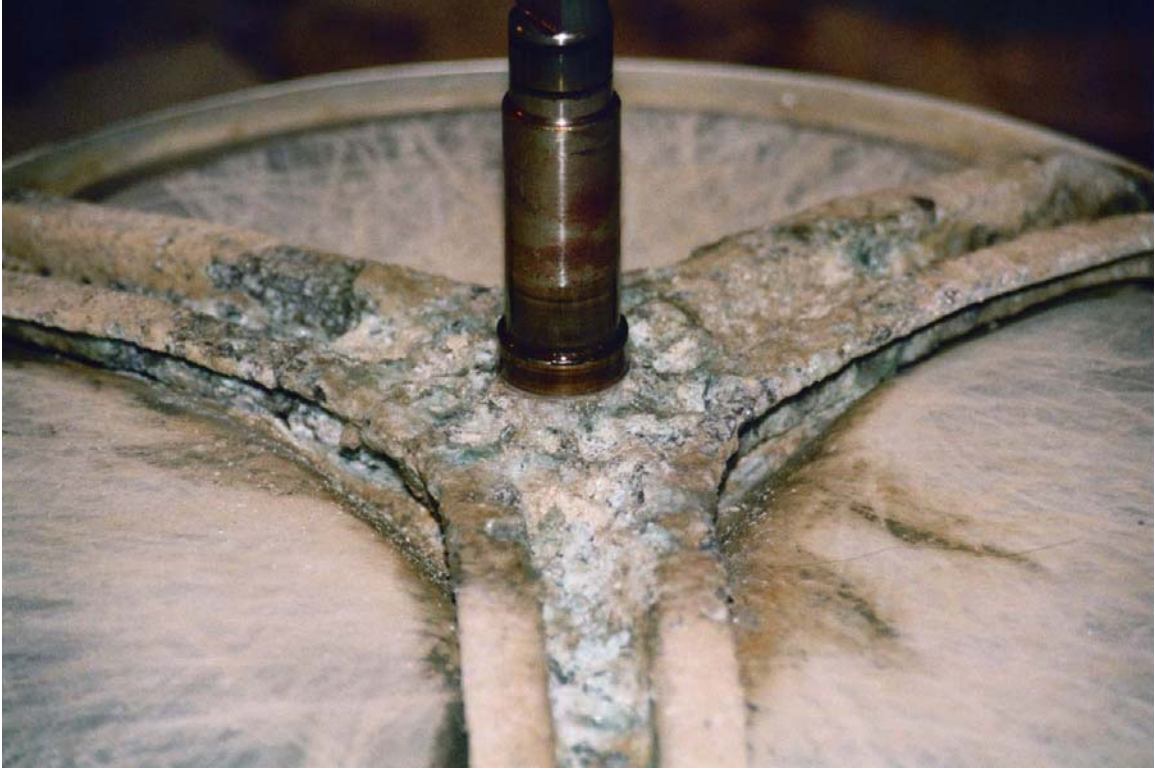
Cracked Support

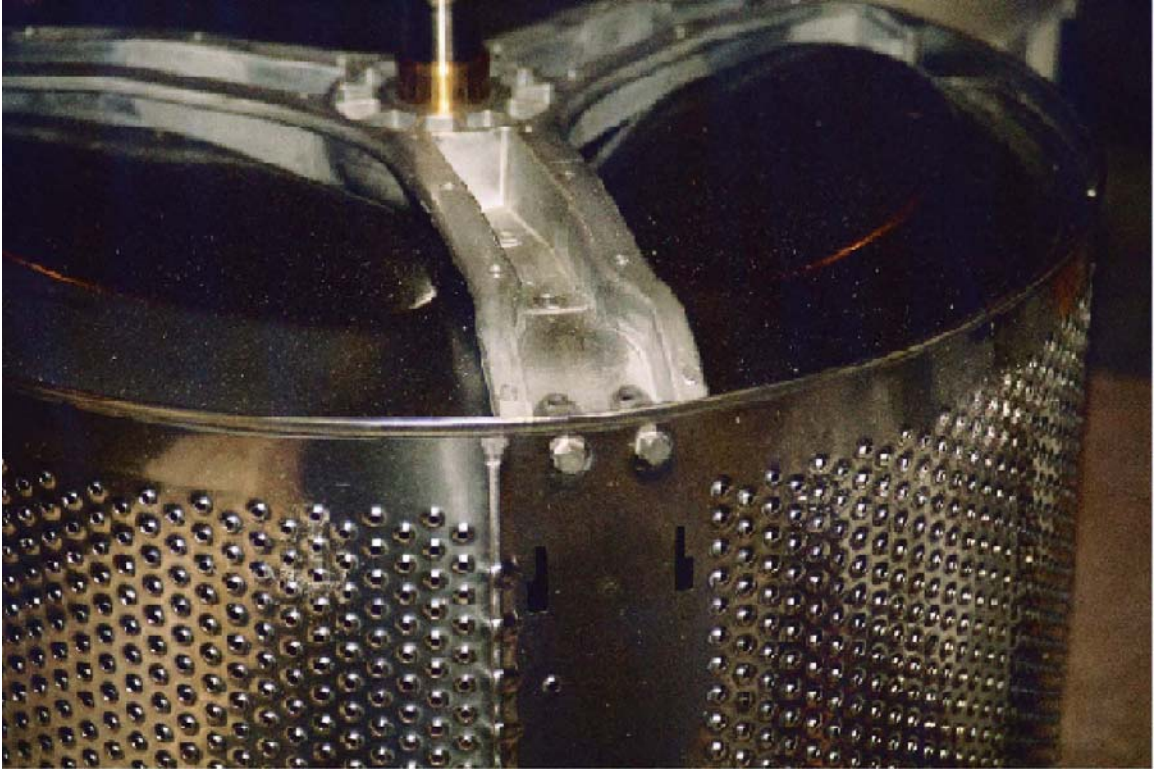
New tub – notice how support is attached (no welds)
